# Efficient Drying of Exterior Truck Parts

Drying and flashing off water-based paints is a time and energy consuming job to do. The Swedish commercial vehicle manufacturer Scania gives an example of how much a change in the drying process may improve the situation. They retrofitted their Meppel, Netherlands, facility implementing efficient technology at reasonable cost and without extensive rebuilding.

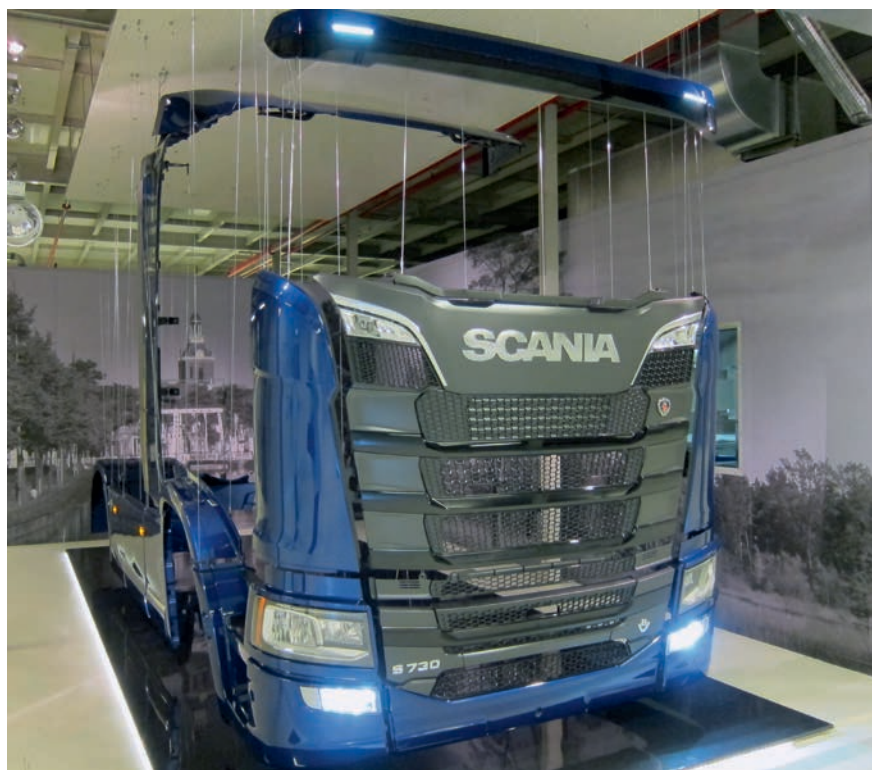
Scania paint exterior truck parts at their Meppel (Netherlands) site for assembly at their three European assembly facilities located at Zwolle (Netherlands), Angers (France) and Södertälje (Sweden)

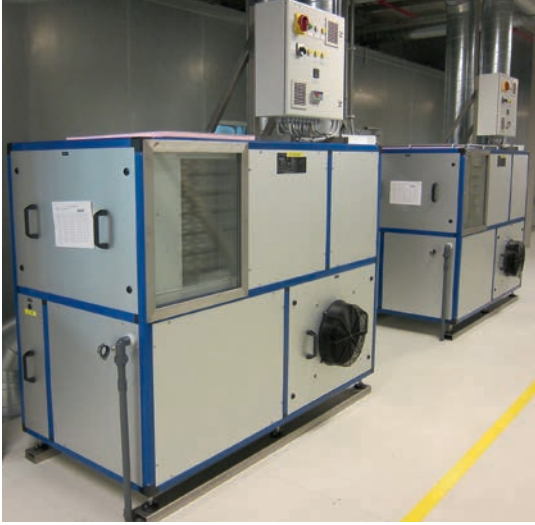
Two compact condensation drying systems provide adequate air-conditioning for the painting process. Dry air is passed over the items to be dried absorbing humidity in the process.

in one big condensation drying system. The systems are sized 2400 mm long, 1100 mm wide and 1800 mm high, and have a power rating of 10.95 kWh each. “If we had bought a single system it would have been too bulky to be taken to the upper level at all” explains van Steeg their choice in retrospect. Also, doors, hallways and corridors are narrow enough to preclude the installation of a single, big system. “This was a smart way of conveniently achieving a good result.”

The Airgenex heat pump based condensation drying systems are vital for Scania’s processing. The basic design of the system was developed by Harter more than 20 years ago. It has since been employed in various industrial applications. The system enables drying at low temperatures which makes it ideally suited for drying paint coats. Paint coated surfaces dry from the inside out in a uniform way. Dry and, thus, unsaturated air is passed to the flashing-off zone where it absorbs moisture. The moist air is then routed to the dehumidification module where it is stripped of the moisture it carries. Excess water together with the solvent is condensed and collected in a separate container. This way, the relative humidity in the flashing-off zone may be reduced from 65 to 23 percent. Drying times are very short due to the underlying physics of the process, i.e. water is absorbed from the paint. Chemi-

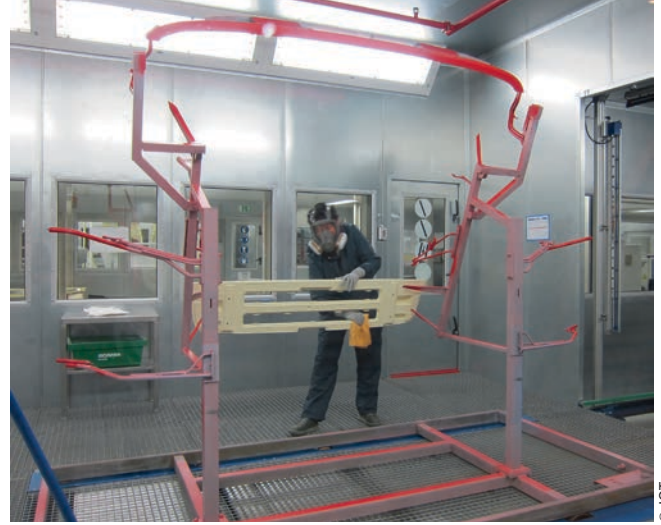
To minimize water input into the downstream paint coating process parts are finish shammed if required.
