Efficient Drying of Exterior Truck Parts

Drying and flashing off water-based paints is a time and energy consuming job to do. The Swedish commercial vehicle manufacturer Scania gives an example of how much a change in the drying process may improve the situation. They retrofitted der Meppel, Netherland, facility implementing efficient technology at reasonable cost and without extensive rebuilding.

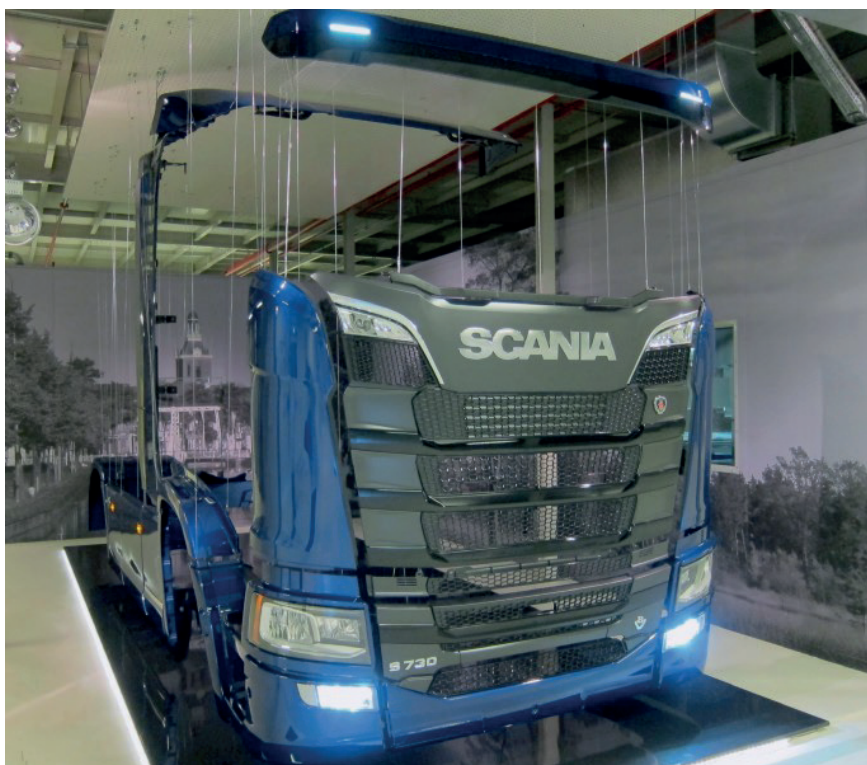
Scania paint exterior truck parts at their Meppel (the Netherlands) site for assembly at their three European assembly facilities located at Zwolle (the Netherlands), Angers (France) and Södertälje (Sweden)

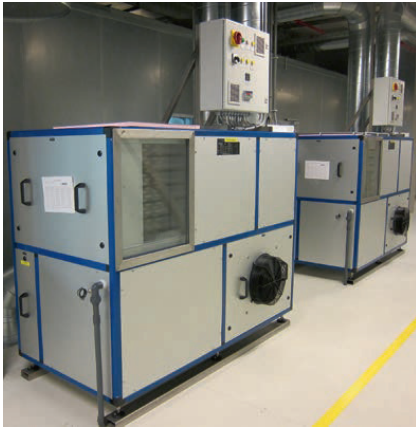
Two heat pump modules condition the process air to provide the correct environmental conditions for the drying process. Extremely dry air is passed over the items to be dried to remove humidity – at low temperatures.

processing. The basic design of the system was developed by Harter back in 1991. It has since been employed in various industrial applications. The system enables drying at low temperatures which makes it ideally suited for drying paint coats. Paint coated surfaces dry from the inside out in a uniform way. Dry and, thus, unsaturated air is passed to the flash-off zone where it absorbs moisture. The moist air is then routed to the dehumidification module where it is stripped of the moisture it carries. Excess water together with the solvent is condensed and collected in a separate container. This way, the relative humidity in the flash-off zone may be reduced from 65 to 23 percent.

Drying times are very short due to the underlying physics of the process, i.e., water is absorbed from the paint. Chemical curing may begin once the water is flashed off the paint. Condensation drying is effected in a closed system with no exhaust air. Constant drying parameters independent from the elements ensure constant drying quality.
